SUBJECT: SR-395, XL 2201  
NSLAC – Francis Avenue to US 2 Structures  
Bridge Foundation Report

## GEOTECHNICAL REPORT

### SR 395 – NSLAC – Francis Avenue to US 2 Structures

XL-2201

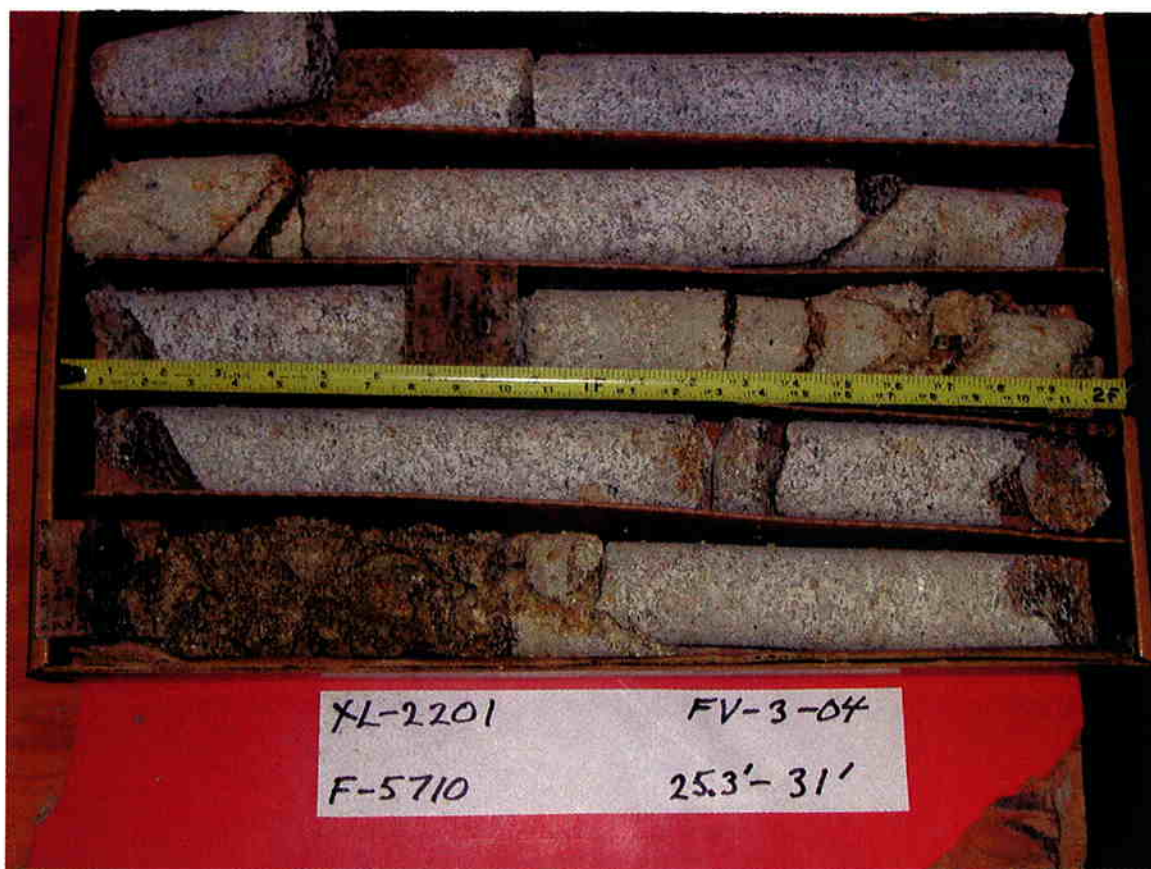
FV-3-04

25.3' - 31'

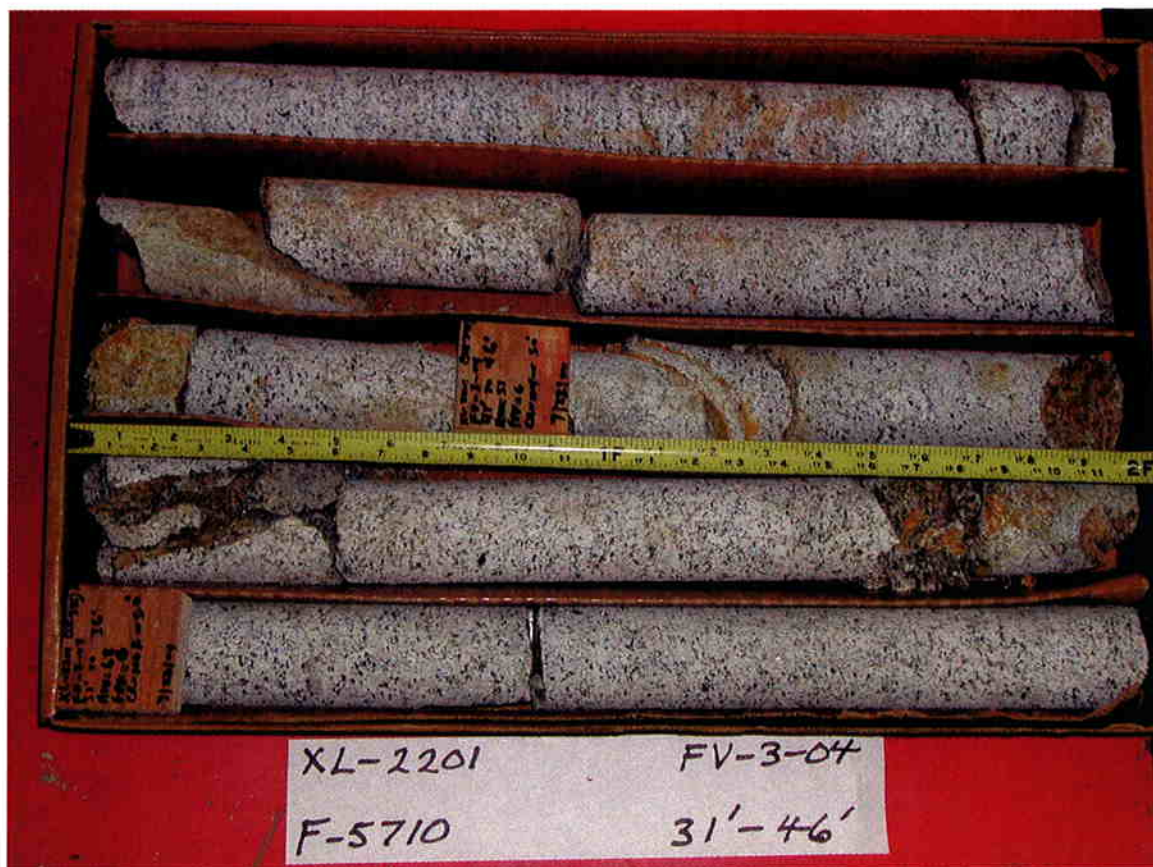
FV-3-04

31'-46'

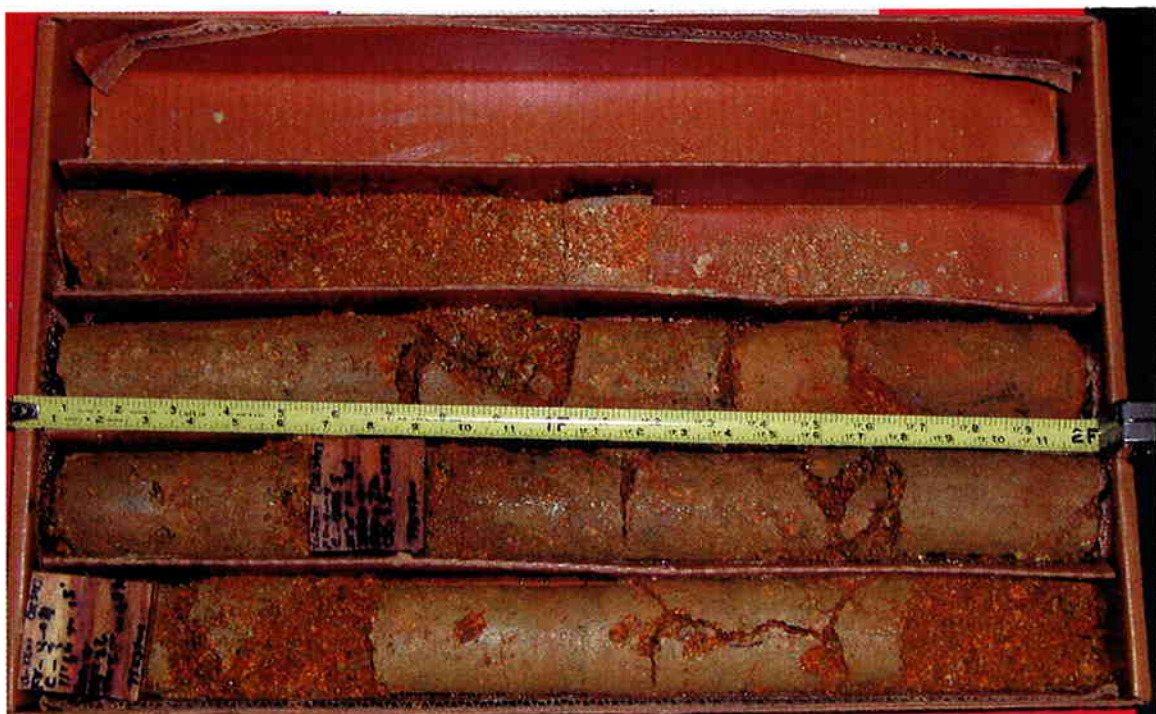
FV-4-04

11.5' - 20'

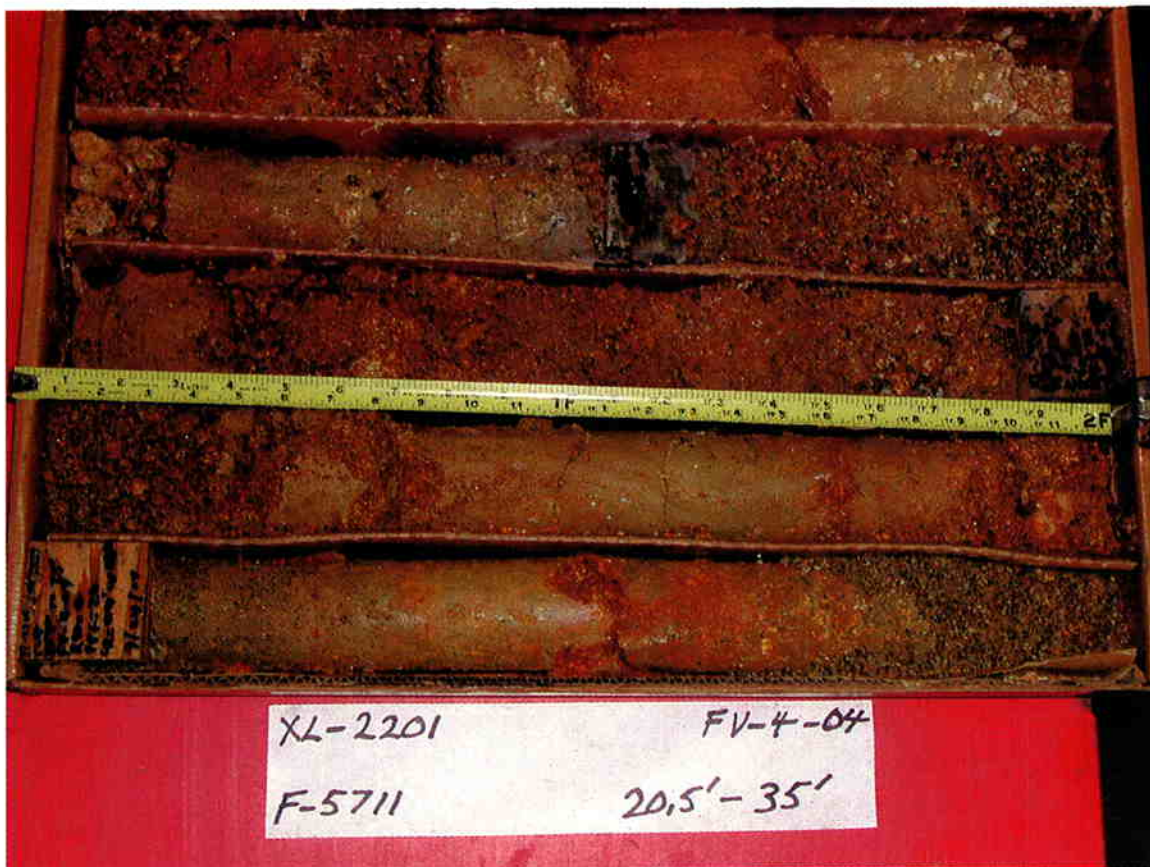
FV-4-04

20.5' - 35'

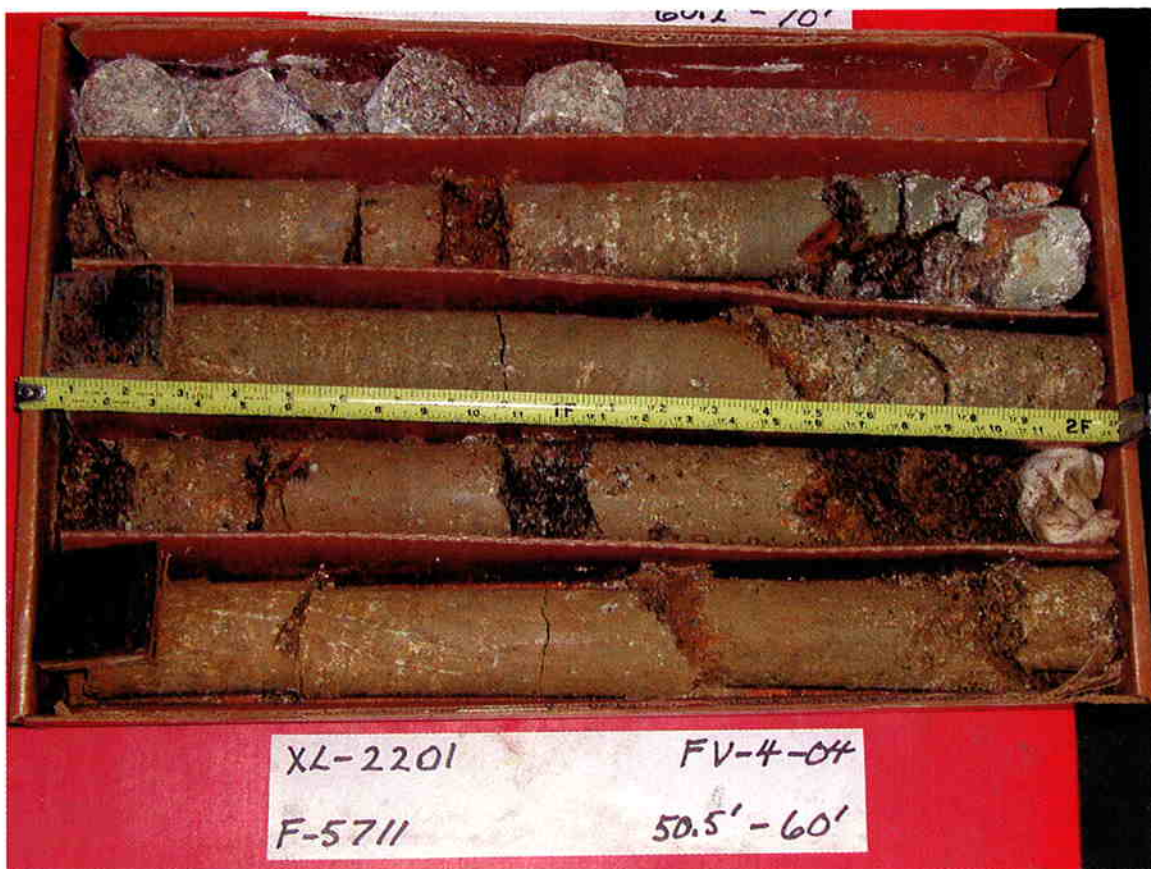
FV-4-04

50.5' - 60'

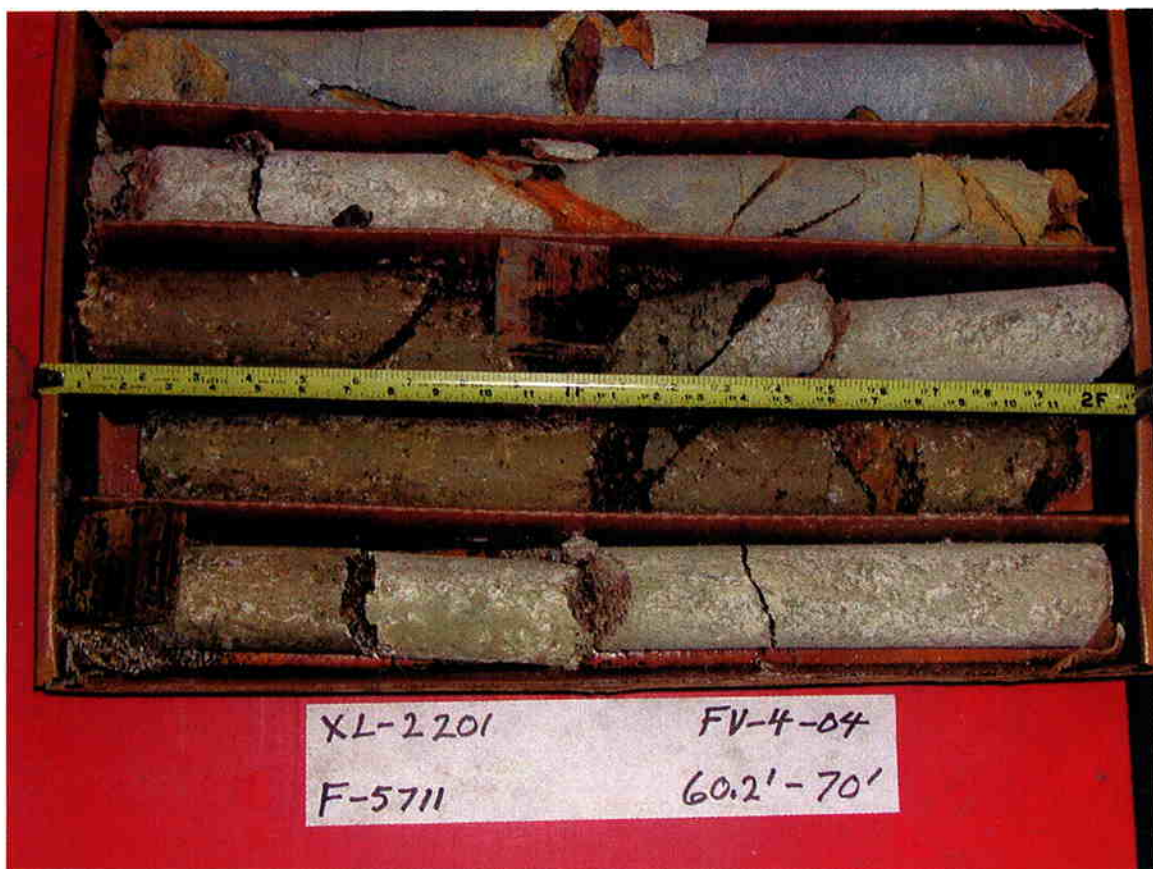
FV-4-04

60.2'-70'

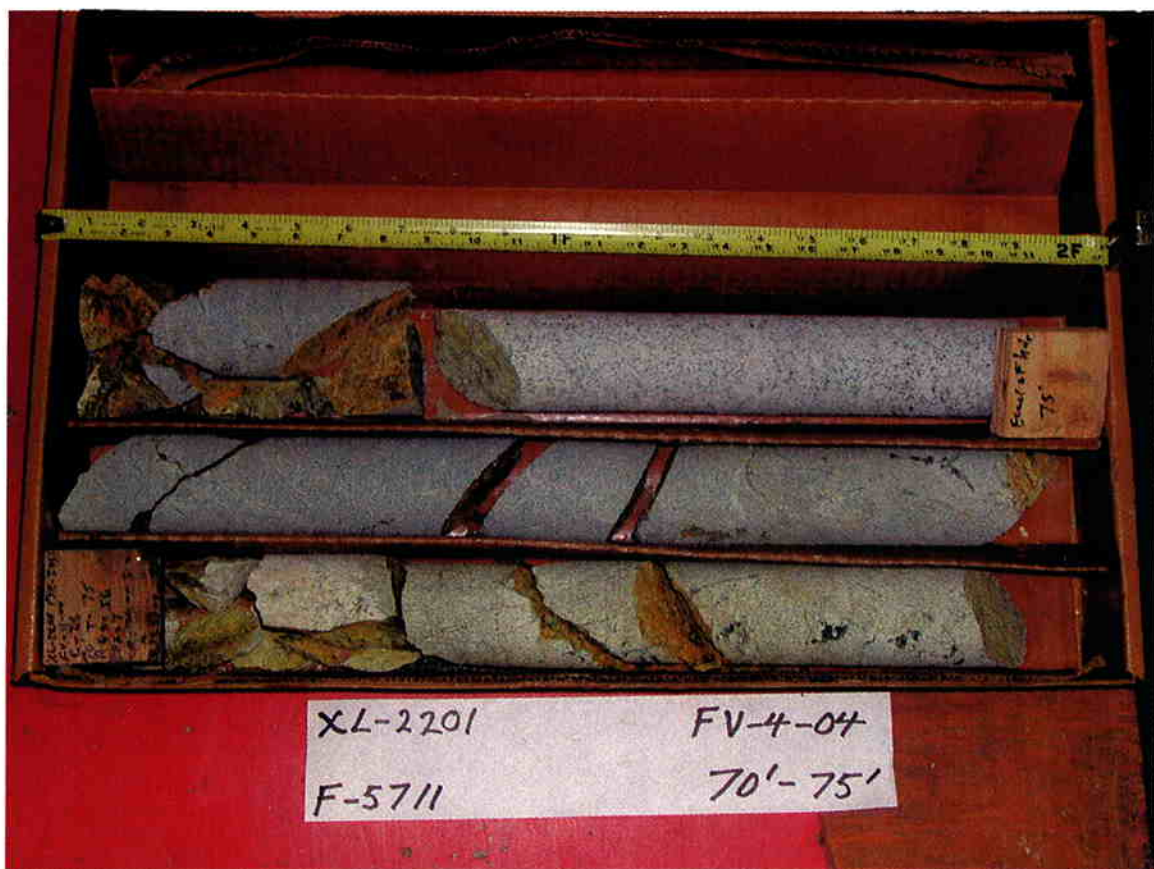
FV-4-04

70'-75'

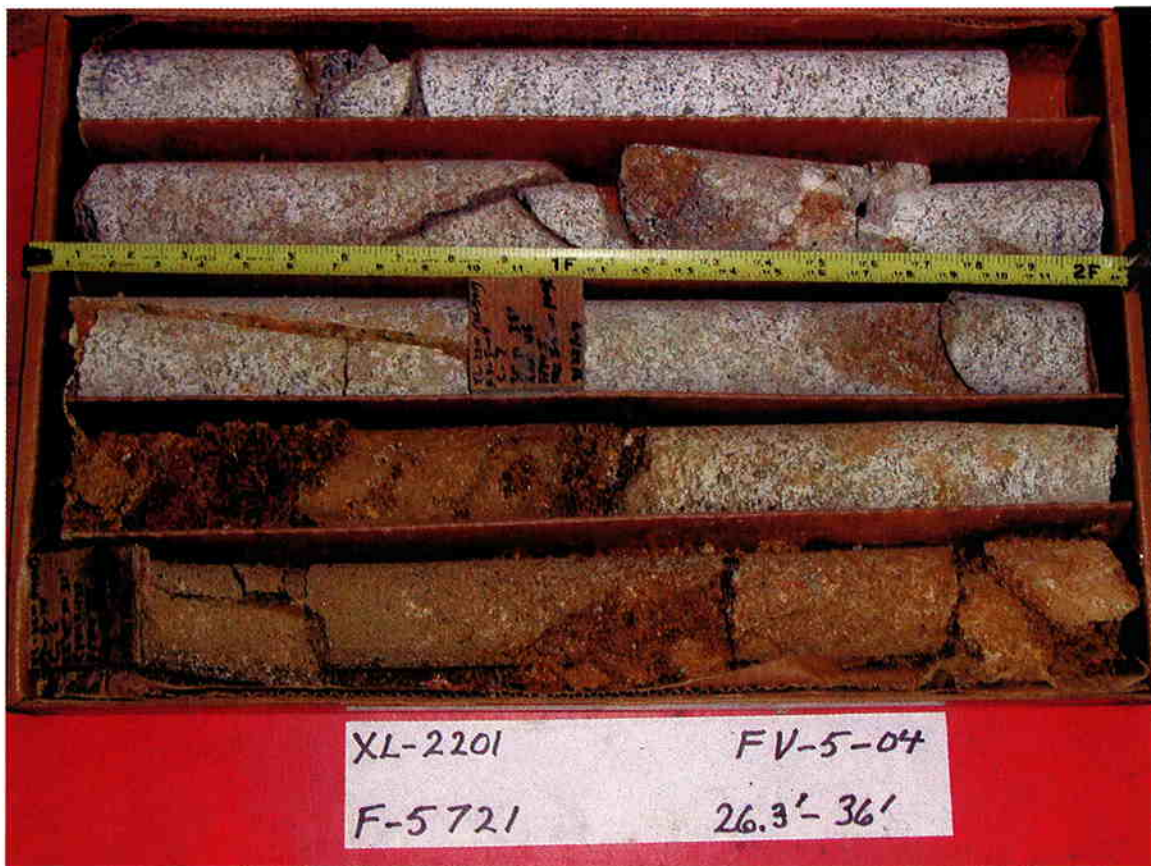
FV-5-04

26.3' - 36'
